Cornell Local Roads Program

Town of Lewisboro

2013

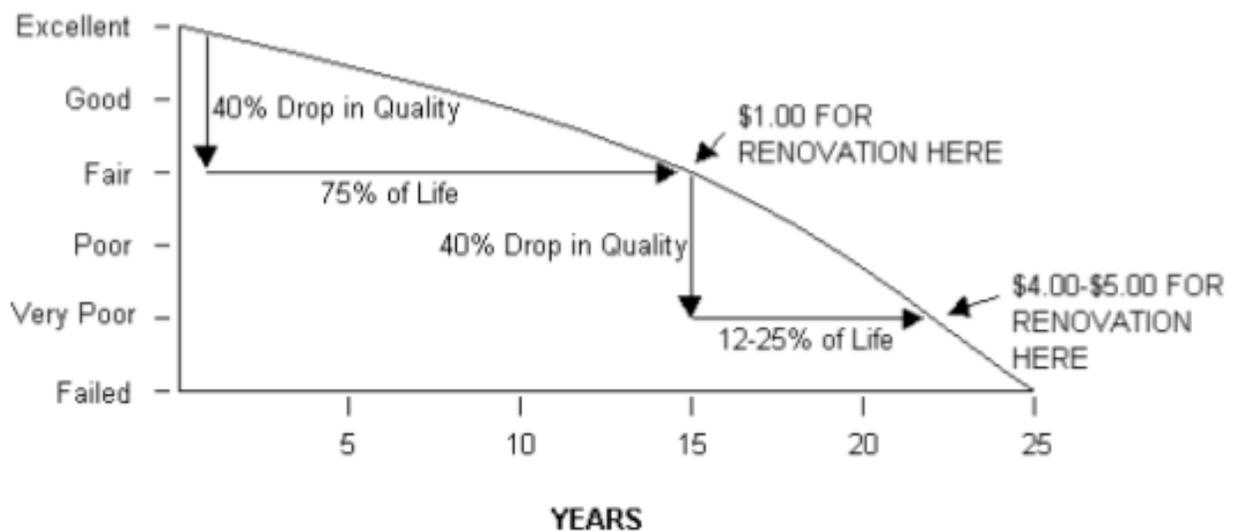
of Lewisboro. This four-day workshop covered the criteria of a good road, the types of damage a road can suffer, repair alternatives, and how to implement Cornell Asset Management Program - Road Surface (CAMP-RS). The basic theory of CAMP-RS is that a road in good condition costs less to maintain than a road in bad condition. As seen in the figure below, the quality drops 40% after the first 75% of a road's serviceable life has expired. At this point, the road transitions from excellent condition to fair condition, and the road will begin to deteriorate at an even quicker rate. As the road deteriorates beyond fair condition, the cost to repair it increases accordingly.

For example, a road in fair condition would cost \$1 to fix while a road in poor to very poor condition will cost \$4-5 to fix. With this in mind, the most cost effective strategy is to maintain the quality of the good roads while simultaneously improving the condition of the bad roads.
